## NASA TECHNICAL MEMORANDUM

## NASA TM X-73926

CONCORDE NOISE-INDUCED BUILDING VIBRATIONS
SULLY PLANTATION - REPORT NO. 2
CHANTILLY, VIRGINIA

Staff-Langley Research Center

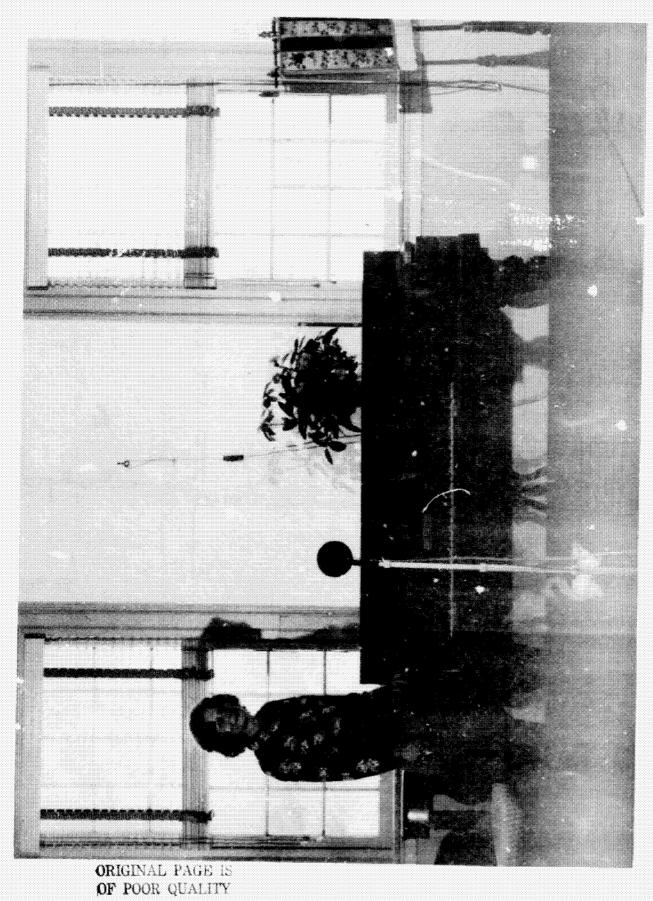
Figure 4.- Location of accelerometer for wall vibration measurements.

Figure 5.- Location of accelerometer for window vibration measurements.

Figure 3 shows a plan view of the first floor of Sully Plantation including test instrumentation locations. In the May test, the instrumentation systems were located in the parlor and south drawing room; in the June test only the north parlor was instrumented. The instrument systems consisted of three accelerometers and one microphone for each room. Installation of the instruments is shown in figures 4 through 6. Microphones were located outside of the building as shown in the figure.
